**ORNL**  
**CENTRAL FILES NUMBER**

60-9-57

DATE: January 10, 1961

SUBJECT: Plutonium Release Incident at Oak Ridge National Laboratory\*

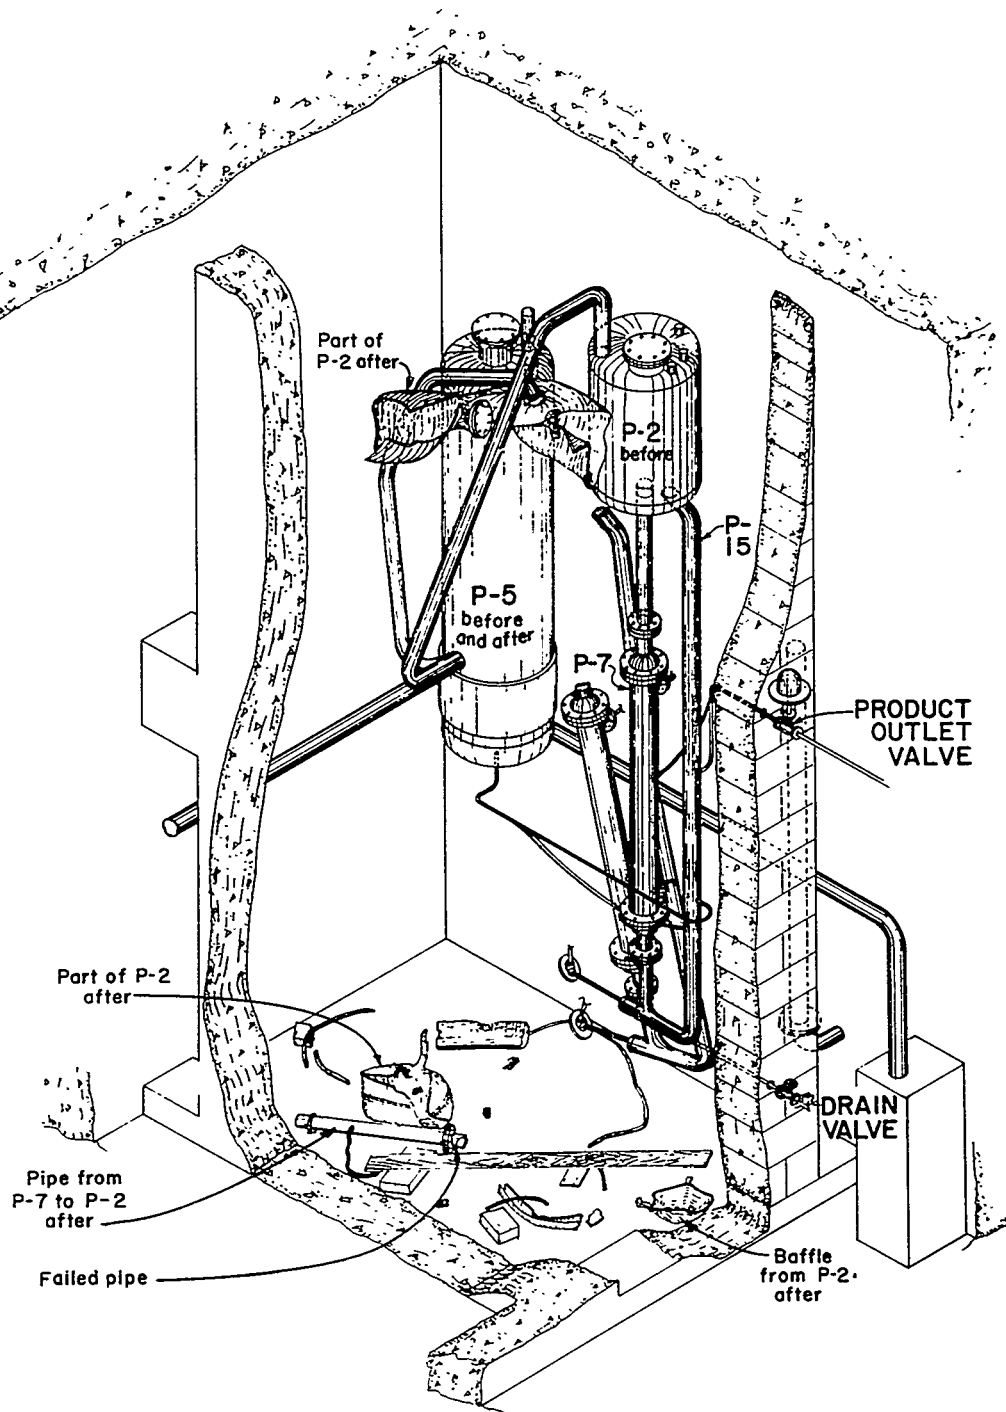
Fig. 1. Intercycle evaporator before and after explosion.

Physical damage from the explosion was confined to the intercycle evaporator equipment and its unit shield wall of dry stacked barytes concrete blocks located in one corner of the cell.

Figure 1 is an isometric drawing of the major evaporator components before and after the explosion. The subcell is 5 ft wide by 7-1/2 ft deep by 15 ft high. The vapor separator (P-2) was torn apart by the indident. A large, badly deformed section that originally was part of the side and top and bottom was found lying on the floor in the subcell. The remainder of separator P-2 was found wrapped around the steam stripper (P-5) which was dented by the impact.

The convection loop (P-15 and P-7) was completely separated from the vapor separator. The flared end of the heat exchanger (P-7) nozzle failed circumferentially and the 2-in.-dia pipe which had connected the heat exchanger (P-7) to the vapor separator (P-2) was found lying on the floor.

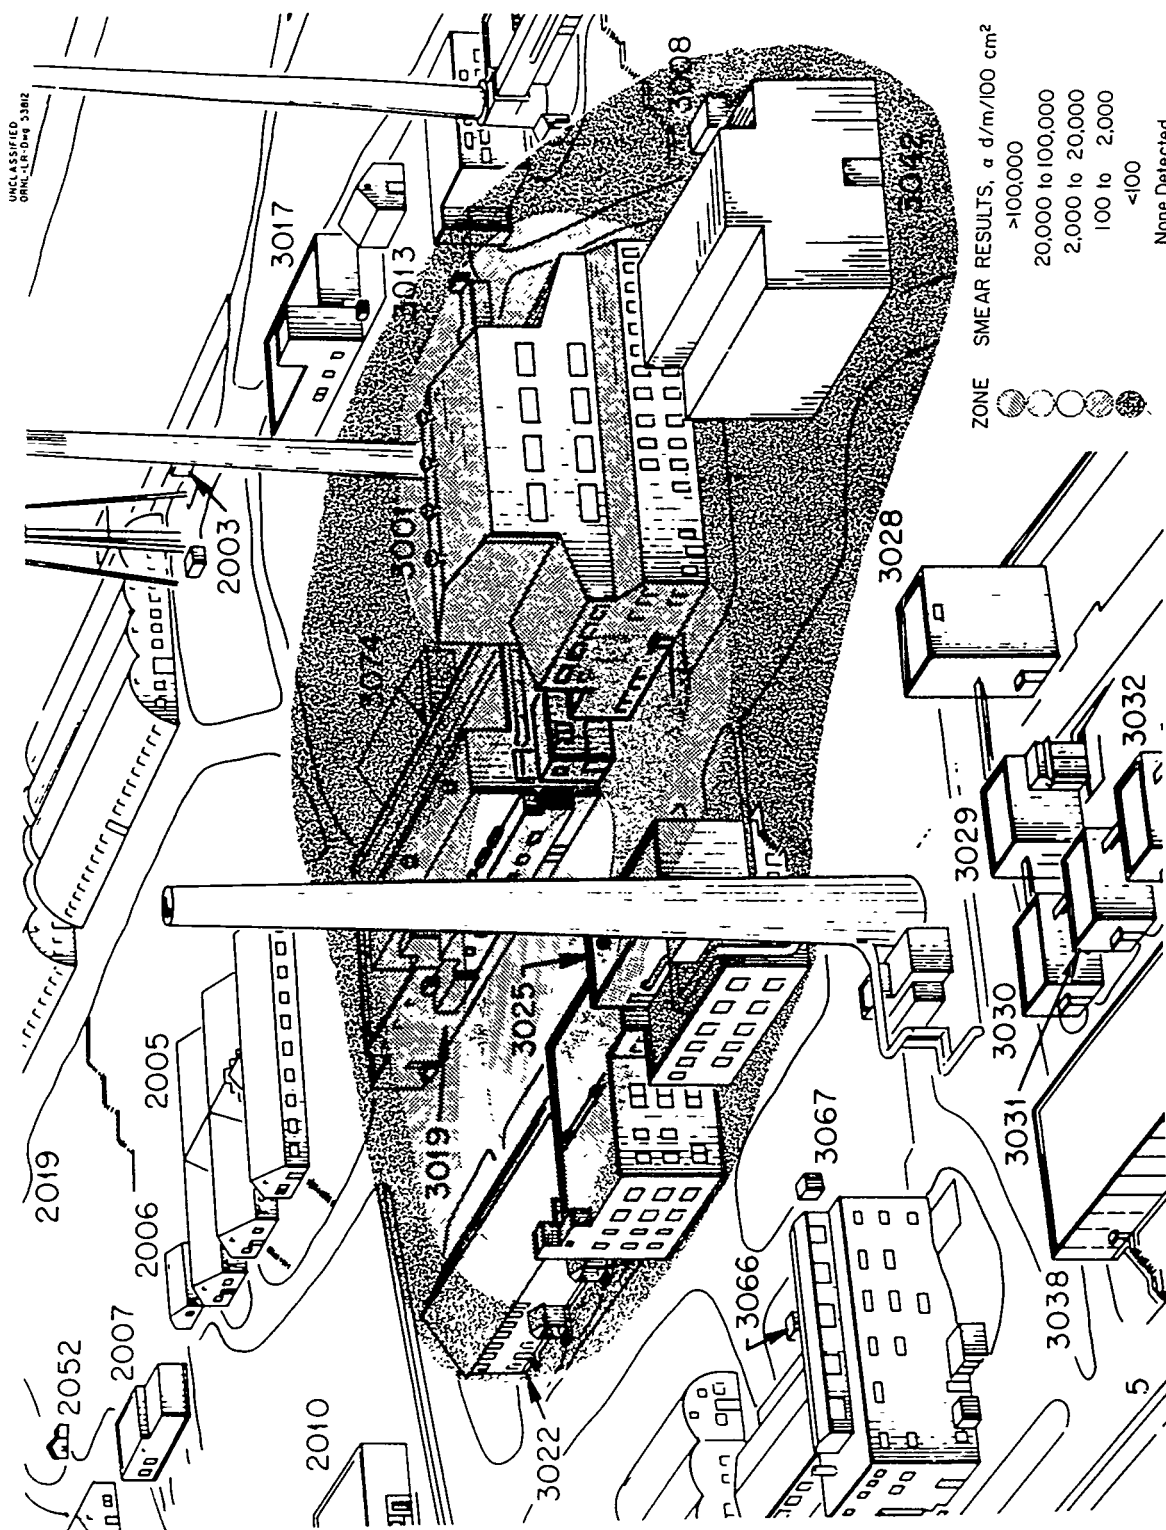
Fig. 4. Plutonium fallout after explosion

Figure 3 is a map of the Laboratory which shows the Radiochemical Processing Pilot Plant and the portion of the Laboratory which was involved in the fall-out. Figure 4 is an enlargement of the affected area. Contamination in some areas was more than 100,000 disintegrations per minute per 100 sq cm. This is about one bpd burden of plutonium per 100 sq cm.

Fortunately the fall-out zone was small because there was only a slight breeze blowing and fall-out was rapid. A Health Physics surveyor drove from the Oak Ridge Research Reactor to the cell 6 door, got out of his truck, and looked toward the cell 6 door from the road; all within 2 minutes after the explosion. The truck was completely contaminated but the surveyor only got his shoes contaminated.

Physics, were resurfaced with emulsified asphalt and gravel. Paint was sprayed on everything else in the area - including roofs, walls, grass, pipes, barrels, and sidewalks. The interiors of nearby buildings were surveyed and cleaned as needed. Except for the Pilot Plant portions of Building 3019, the Graphite Reactor Building, and the roadway just south of these buildings, all Laboratory areas were back in service on Monday morning, November 23.

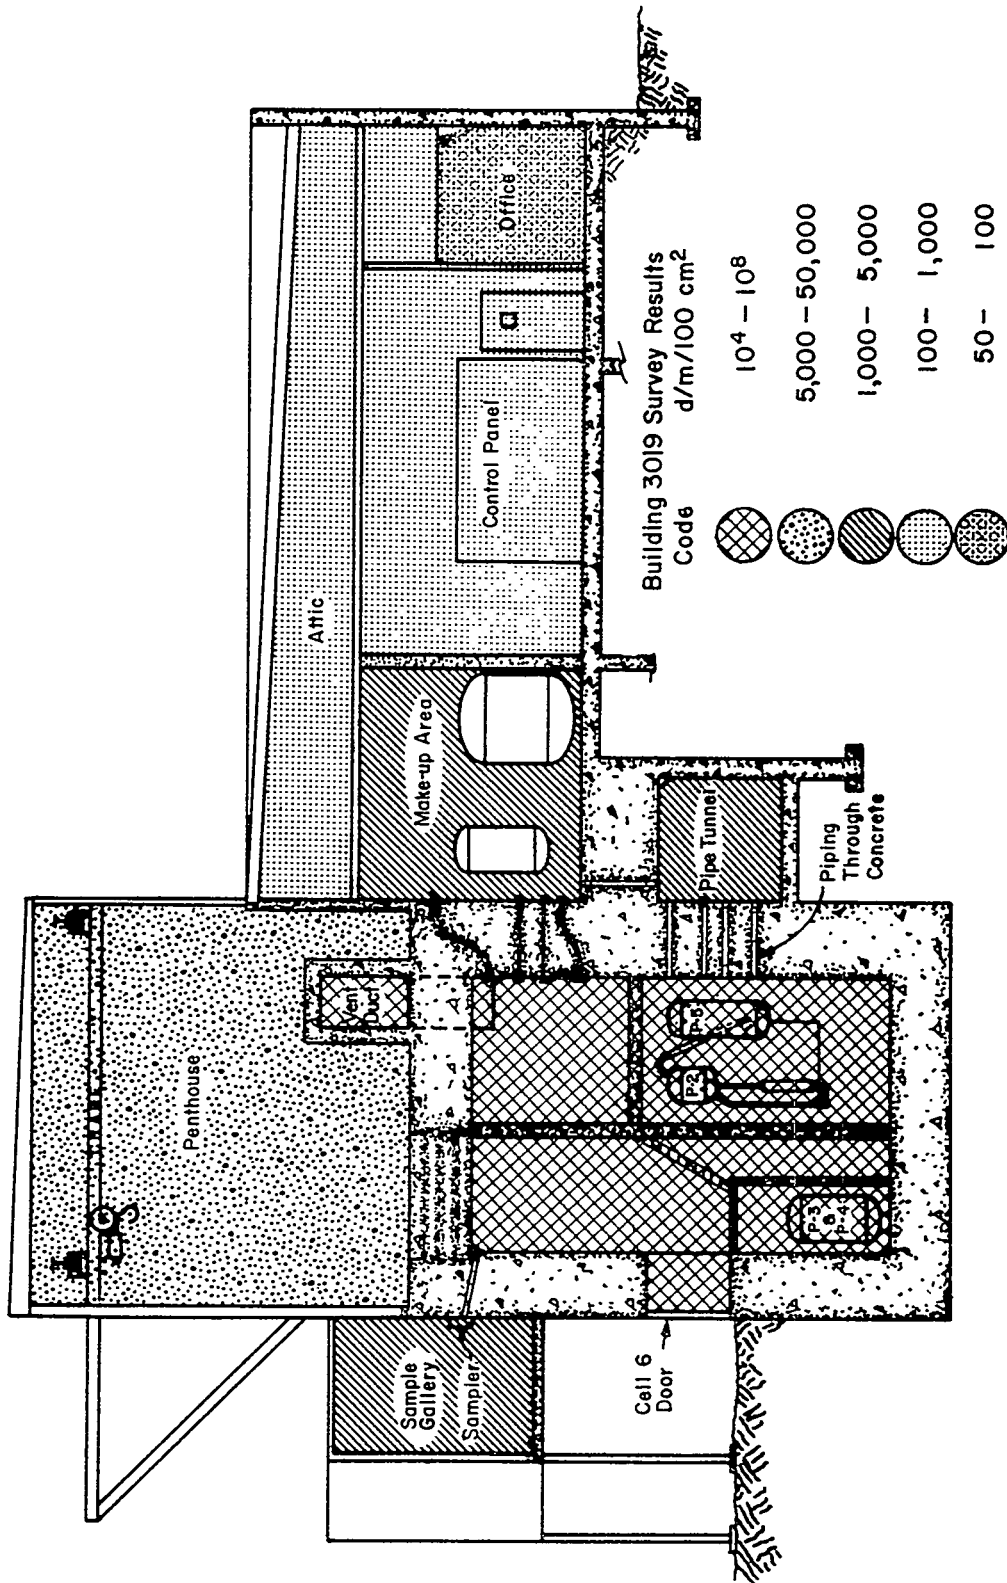
Fig. 5. Sectional elevation through cell 6, Radiochemical Processing Pilot Plant, showing inside contamination levels after explosion.

Figure 5 is a sectional elevation of Building 3019 through the evaporator. The plutonium alpha activity which contaminated streets and buildings in the vicinity of the Radiochemical Processing Pilot Plant was released from that building through the cell 6 door, which is at ground level and opened directly to the outside of the building.

The contamination in the building ranged from  $10^8$  alpha d/m/100 cm<sup>2</sup> in the cell to 50 disintegrations per minute per 100 cm<sup>2</sup> in the offices. Outside the cells, the greatest contamination in the building was in the penthouse.

Open access holes from the processing cell to the make-up area, pipe tunnel, sampling gallery, and penthouse were the paths by which the plutonium escaped the cells to contaminate the interior of Building 3019.

Of the 3500 man days of cleanup about one third were expended in the penthouse. The most difficult area was the 167 by 30 ft ceiling which is constructed of ribbed metal roof decking supported by I-beams. After the unsuccessful use of scrubbing with detergents, scraping, and sanding, the only effective decontamination method found was complete removal of all paint with a chemical paint remover.

Floors were cleaned by removal of the concrete surface and were covered by tile or new concrete and paint. Except for stainless steel which responded to strong acid cleaning, unpainted metal surfaces were particularly difficult to decontaminate and often required grinding until the surface was brightly polished before cleaning specifications were reached.
